Re: Report of Findings  
Fox Run Condominiums – Phase 1 Foundation Repair Design  
Green Engineering Consulting Project GEC10113

Report of Findings  
Fox Run Condominiums  
Phase 1 Foundation Repair Design

Prepared for:  
Fox Run Condo Owners Association

Prepared by:  
Green Engineering Consulting  
P.O. Box 3509  
Sugar Land, Texas 77487

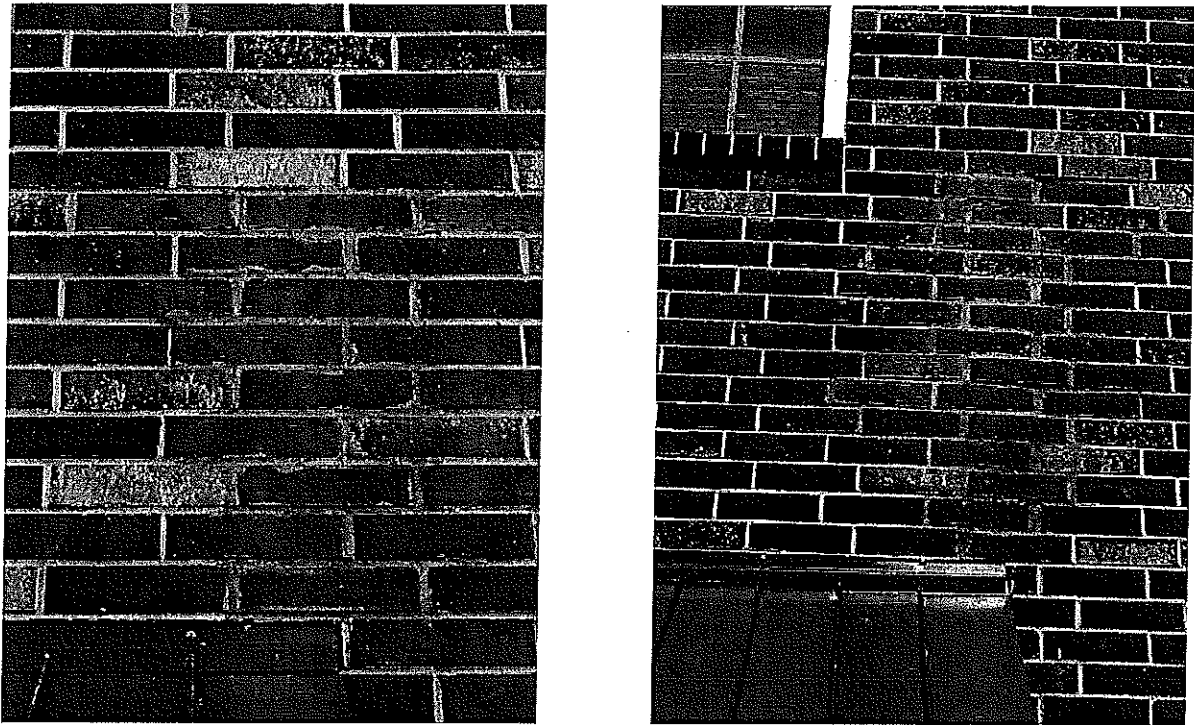
- 4.1. Interior repairs are performed by individual tenants and no records are maintained.
  - 4.2. Repairs to the exterior brick veneer were made by the developer. At least some of these repairs are visible. The extent of any repairs which are not visible, if any, is unknown.

Figure 8 – Typical brick repairs (Bldg 14 left, Bldg 15 right).

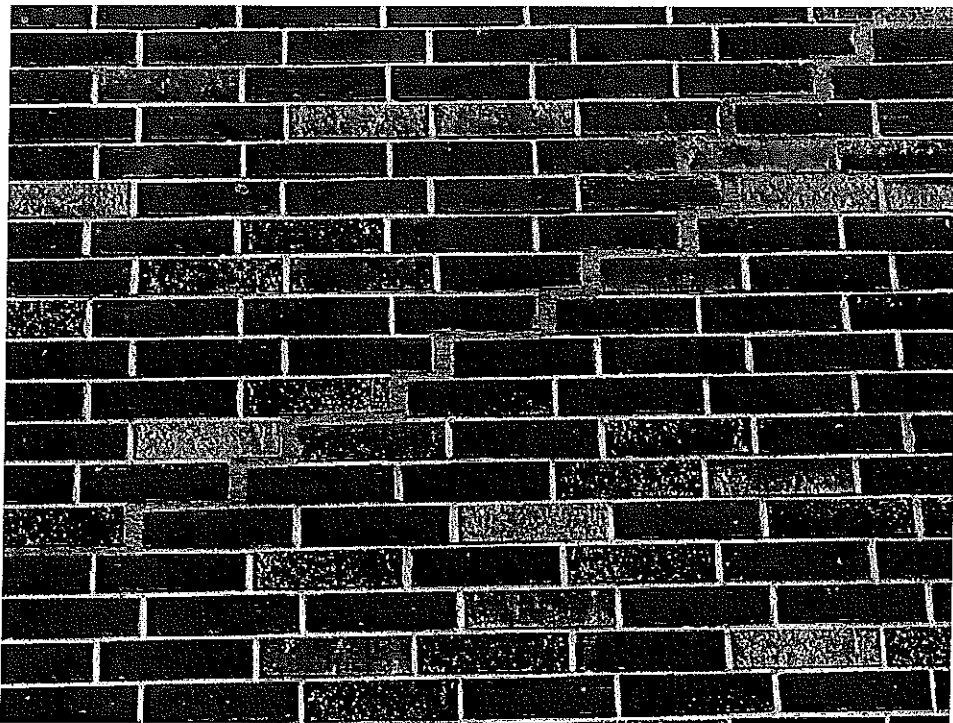
Figure 9 – Typical brick repairs (bldg 15).

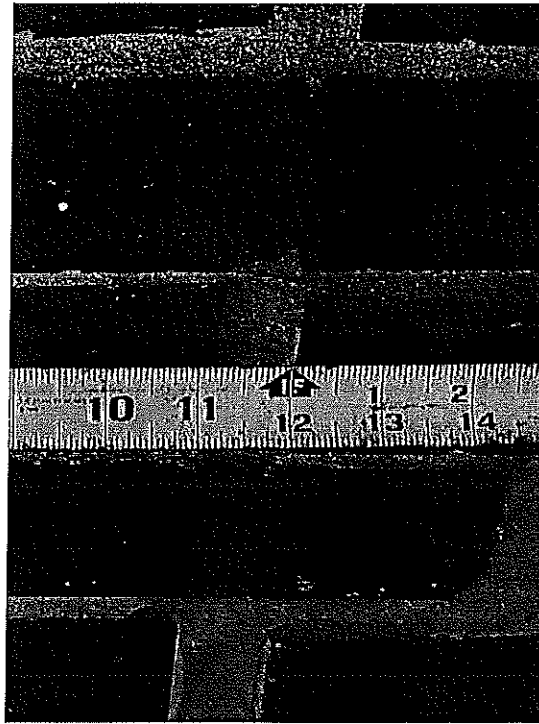
Figure 10 – Repaired mortar joint.

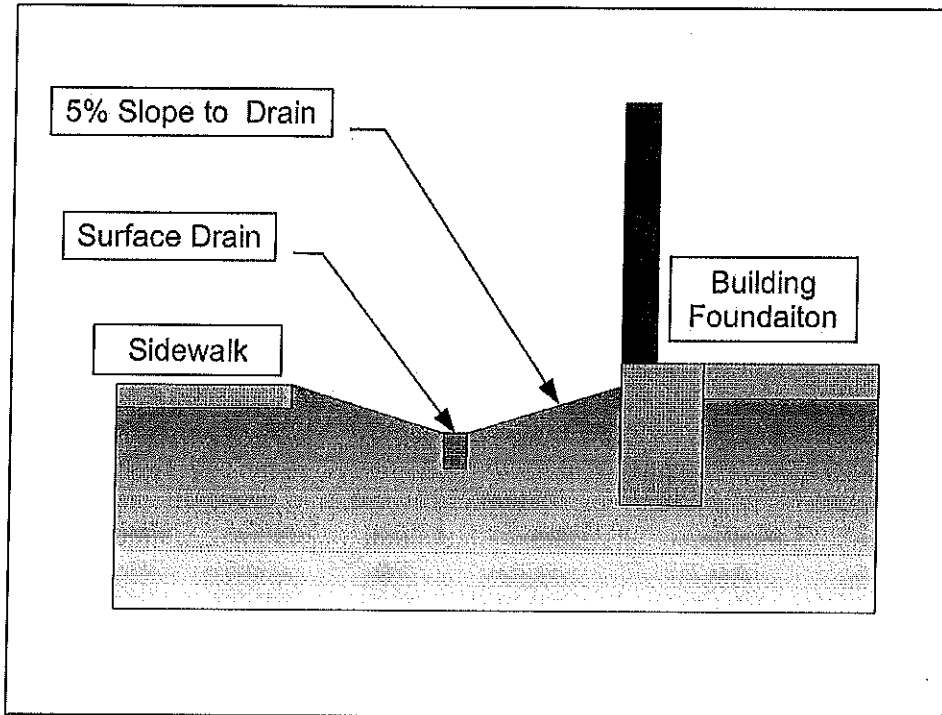
Figure 12 – Proposed remedial drainage.

5. It is my opinion that the drainage and landscaping should be remediated by removing all existing French drains, non-clay soils and landscaping. This should be replaced with fat clays and sod sloped at least 5% away from the building perimeters.

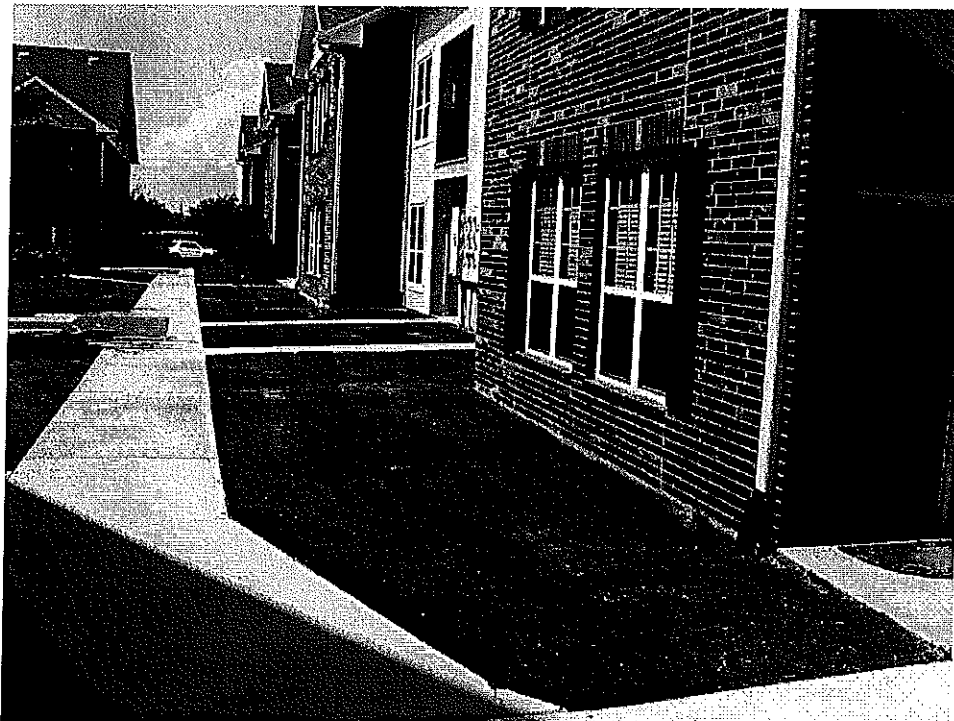
Figure 13 – Typical landscaping at Building 5.

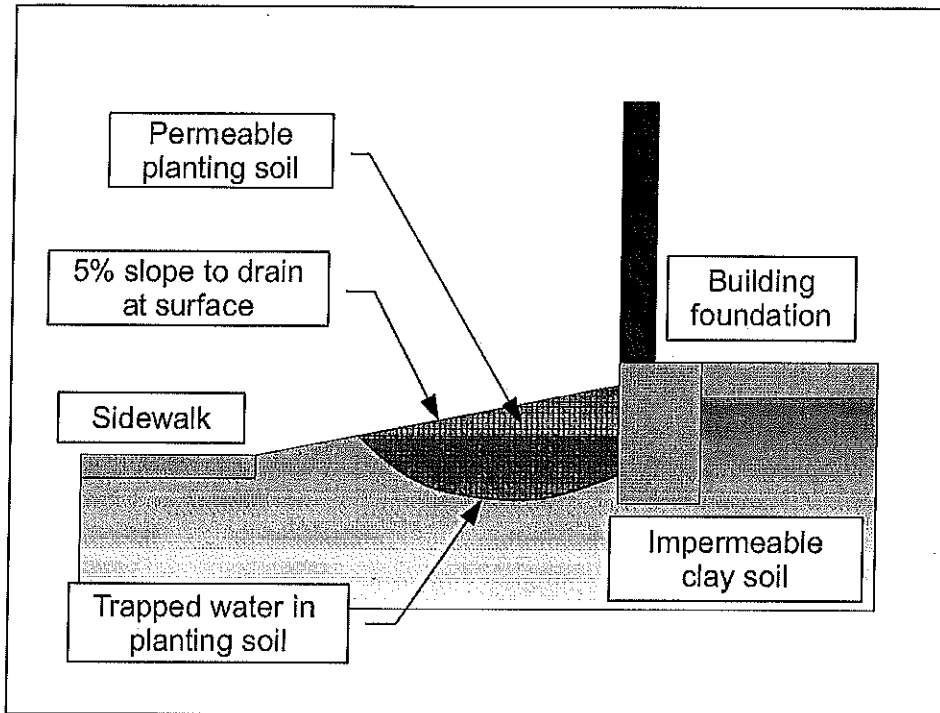
- 2.3. Poor drainage was observed at the building perimeters, and water was observed in many test pits dug at the building perimeters by HOV Services in April 2009.

Figure 14 – Typical trapped drainage at planting beds.
