Re: Report of Findings  
Fox Run Condominiums – Phase 1 Foundation Repair Design  
Green Engineering Consulting Project GEC10113

Report of Findings  
Fox Run Condominiums  
Phase 1 Foundation Repair Design

Prepared for:  
Fox Run Condo Owners Association

Prepared by:  
Green Engineering Consulting  
P.O. Box 3509  
Sugar Land, Texas 77487

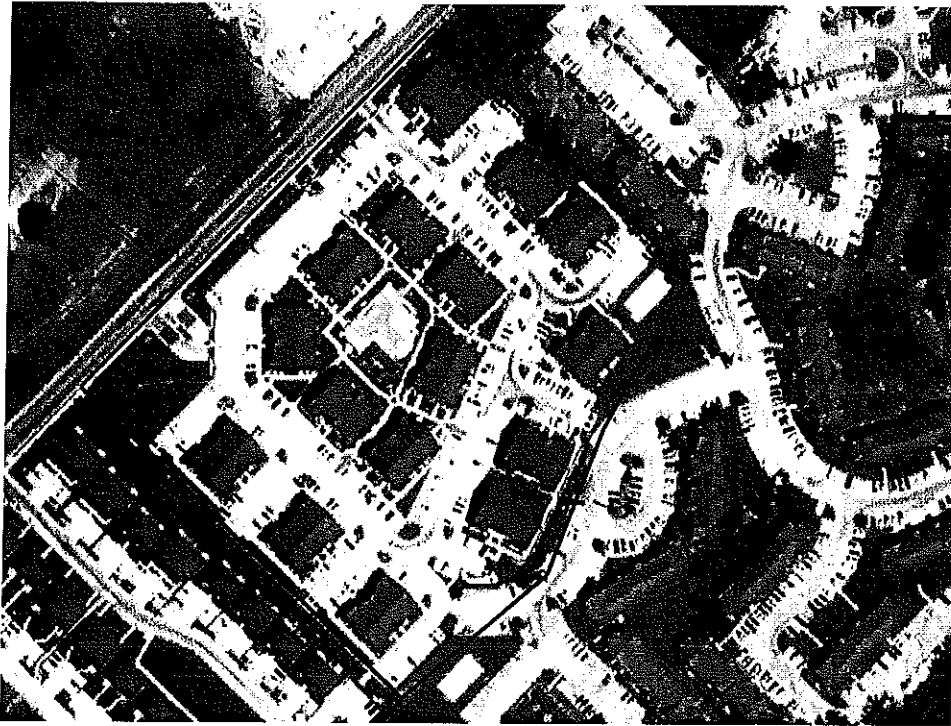
Figure 1 – Site layout (Aug 2006 photo).

The Fox Run Condominiums consist of 16 buildings with substantially the same design and construction (Figure 1). The buildings are designated as Building 1 through Building 16 (Figure 2). Each building has the following generally features:

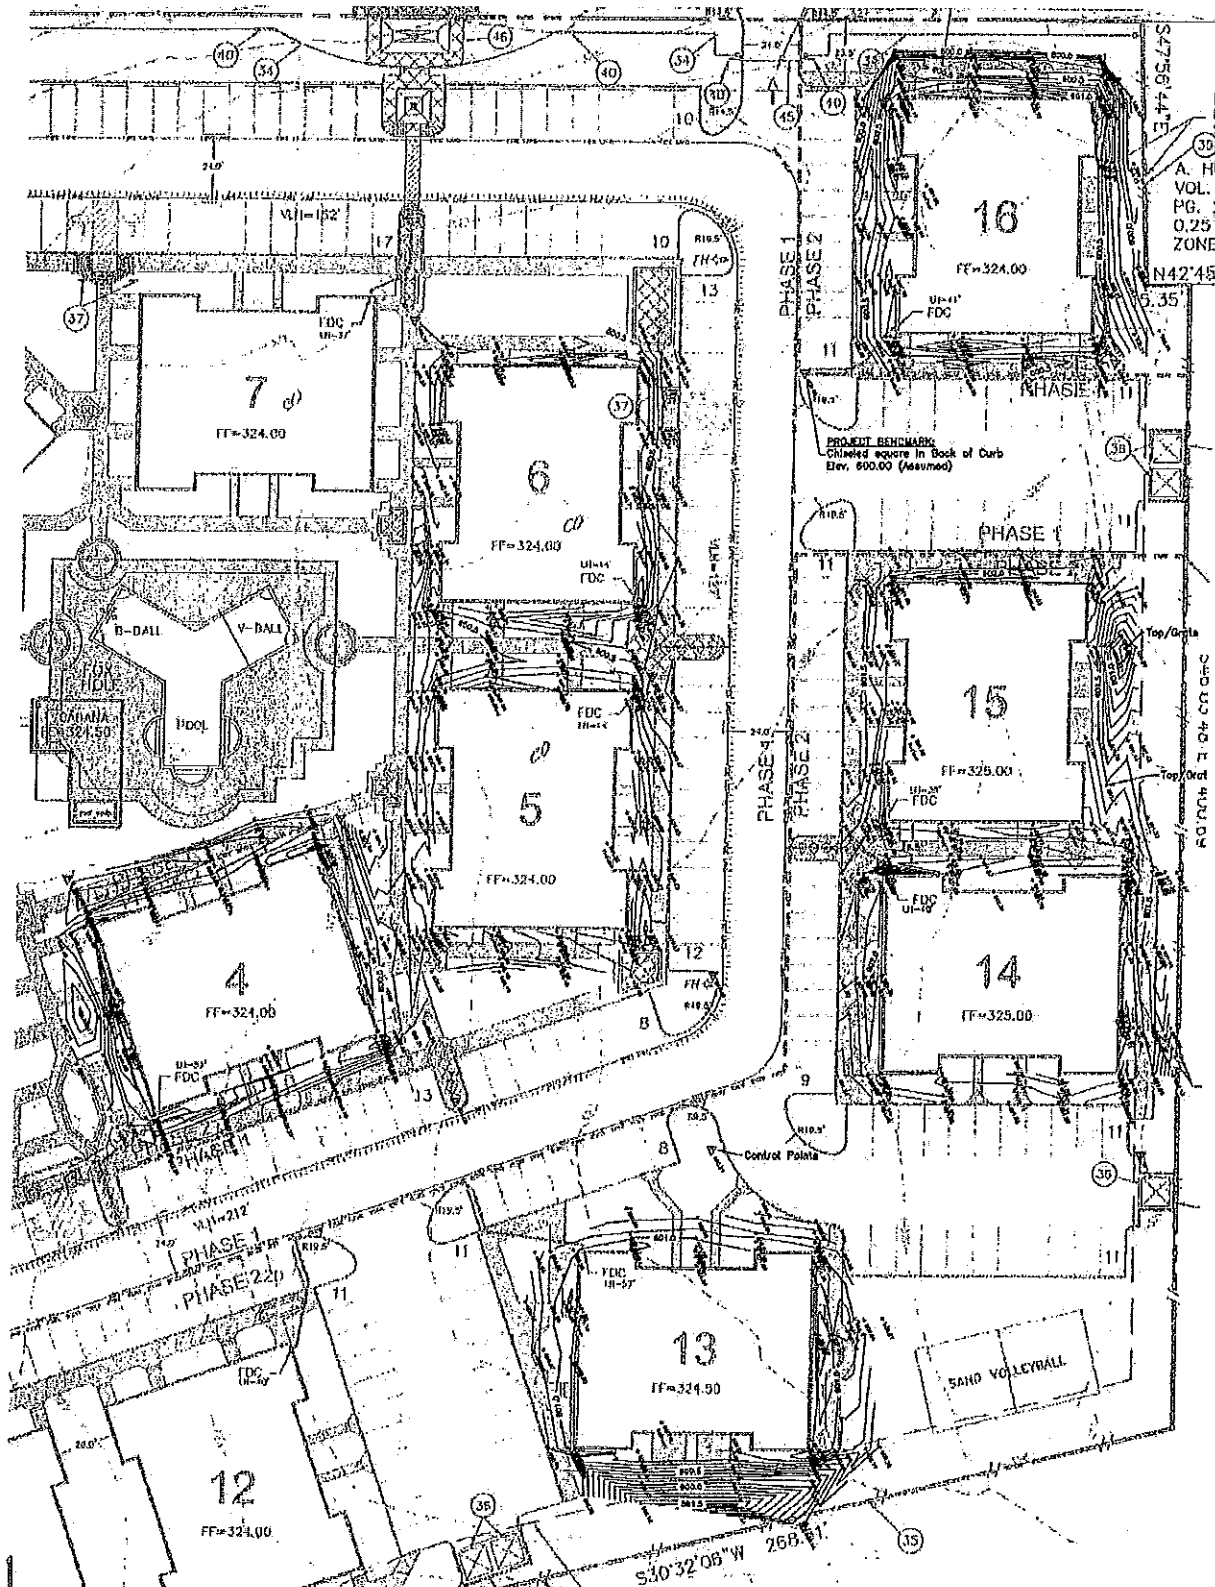
Figure 7 – McClure and Browne site topography.

A site topographic survey of the area within approximately 15 feet of the perimeter of buildings 4, 5, 6, 13, 14, 15 and 16 was performed by McClure and Browne Engineering/Surveying (Figure 7) on September 2009.
